May 2019 Board Meeting

Field Tour Itinerary

Carr Fire Field Tour Stops

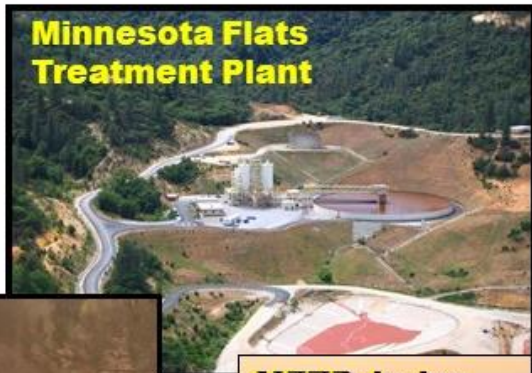
Minnesota Flats Treatment Plant

The MFTP is the heart of the IMM cleanup and treats the four main sources of AMD that are collected, stored and treated at the Site.

- Treats 50 to 6,000 gallons per minute (gpm) of AMD
- Requires continuous lime deliveries for treatment process
- Plant operations: 16 full time staff, 100+ contractors, \$6-10M/yr
- What's unique? Scale and magnitude of operation

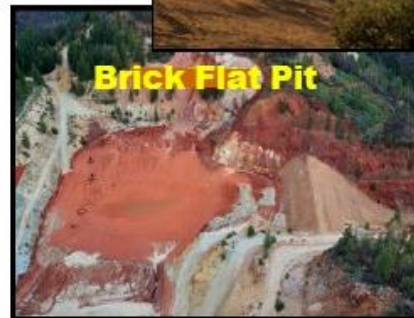
Brick Flat Pit

BFP dam stores treated sludge from the MFTP. Sludge is hauled up the Mountain once per year after drying out in the four sludge drying beds at the MFTP area.

- CERCLA has a preference for on-site management of contamination
- Approximately 75 feet of sludge stored in the pit right now
- Dam will be raised at least one more time to create more capacity

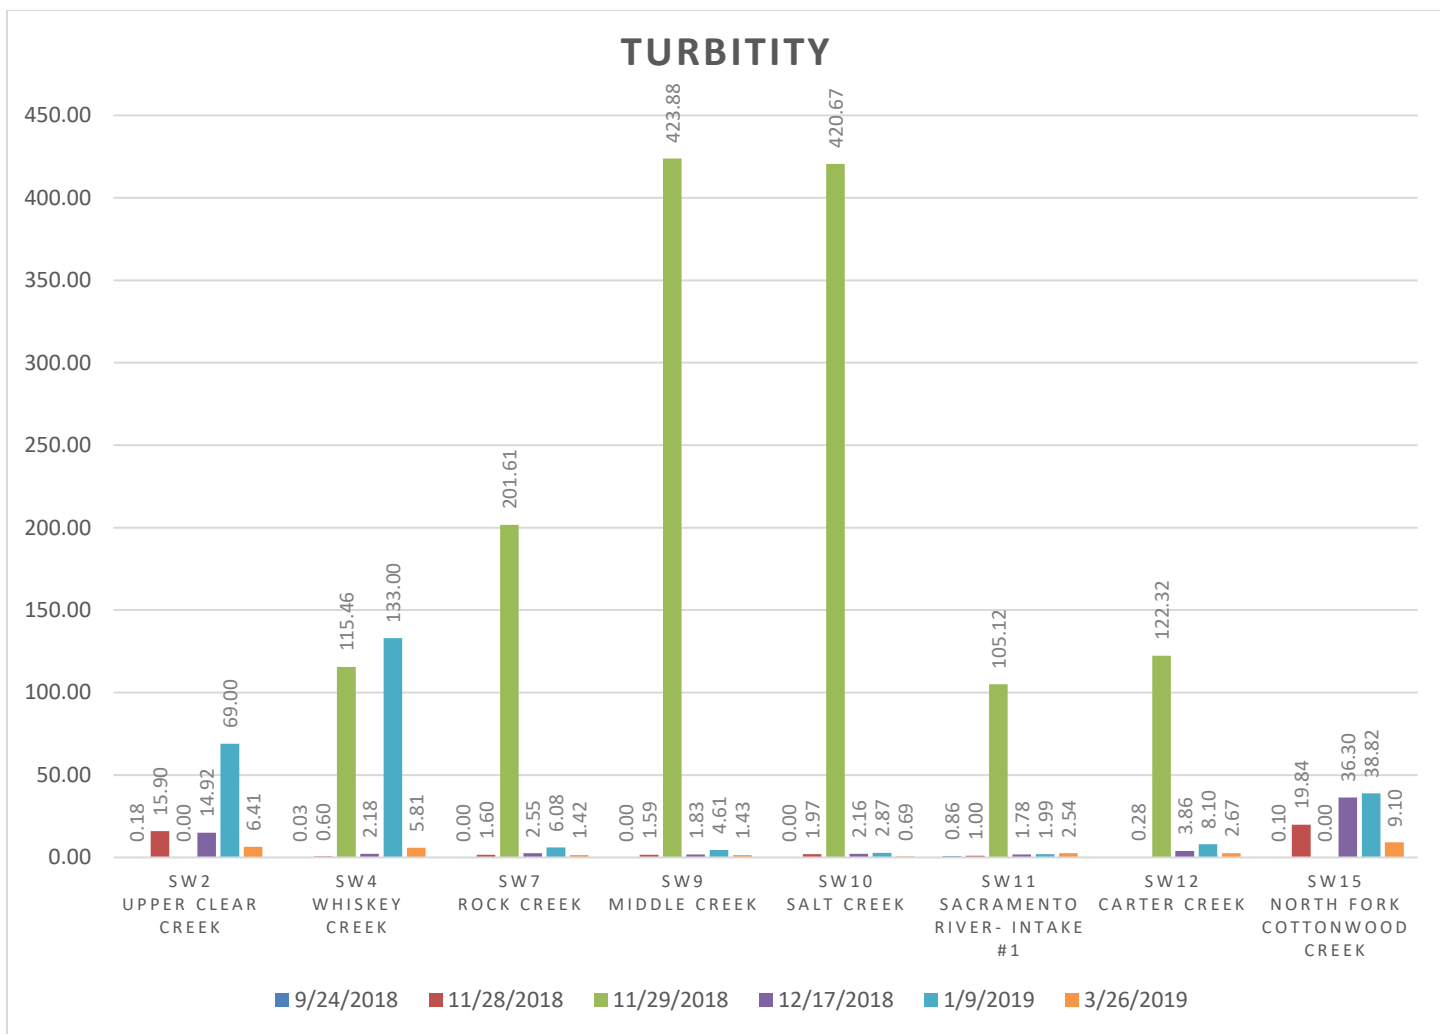
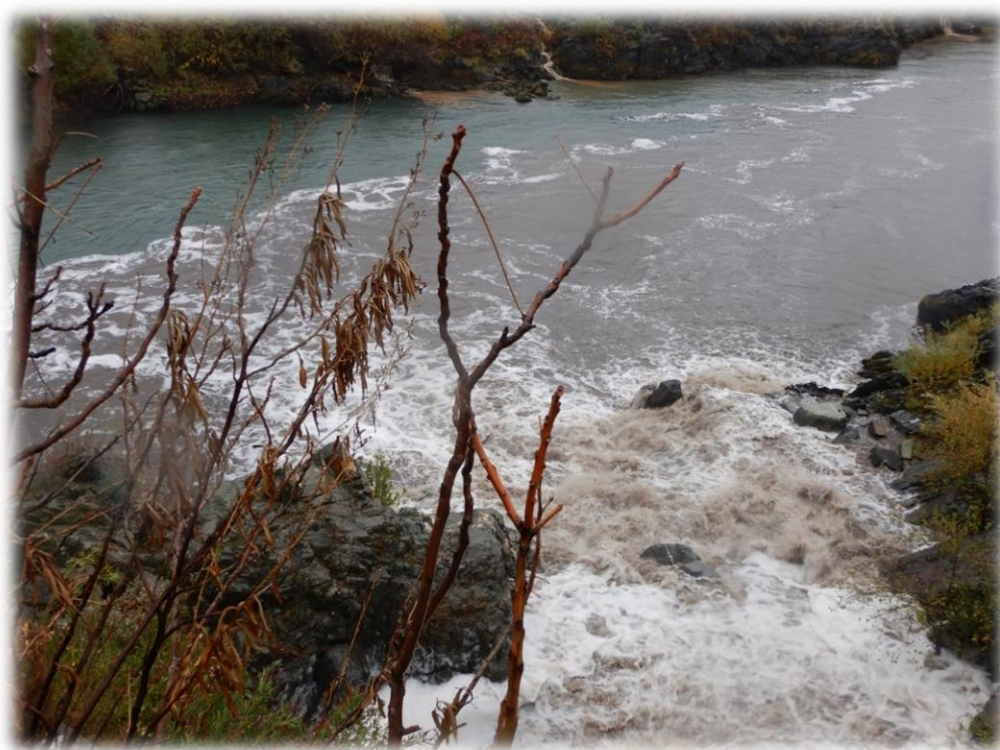
***Elevated turbidity at confluence of Rock Creek and Sacramento River
29 November 2018***

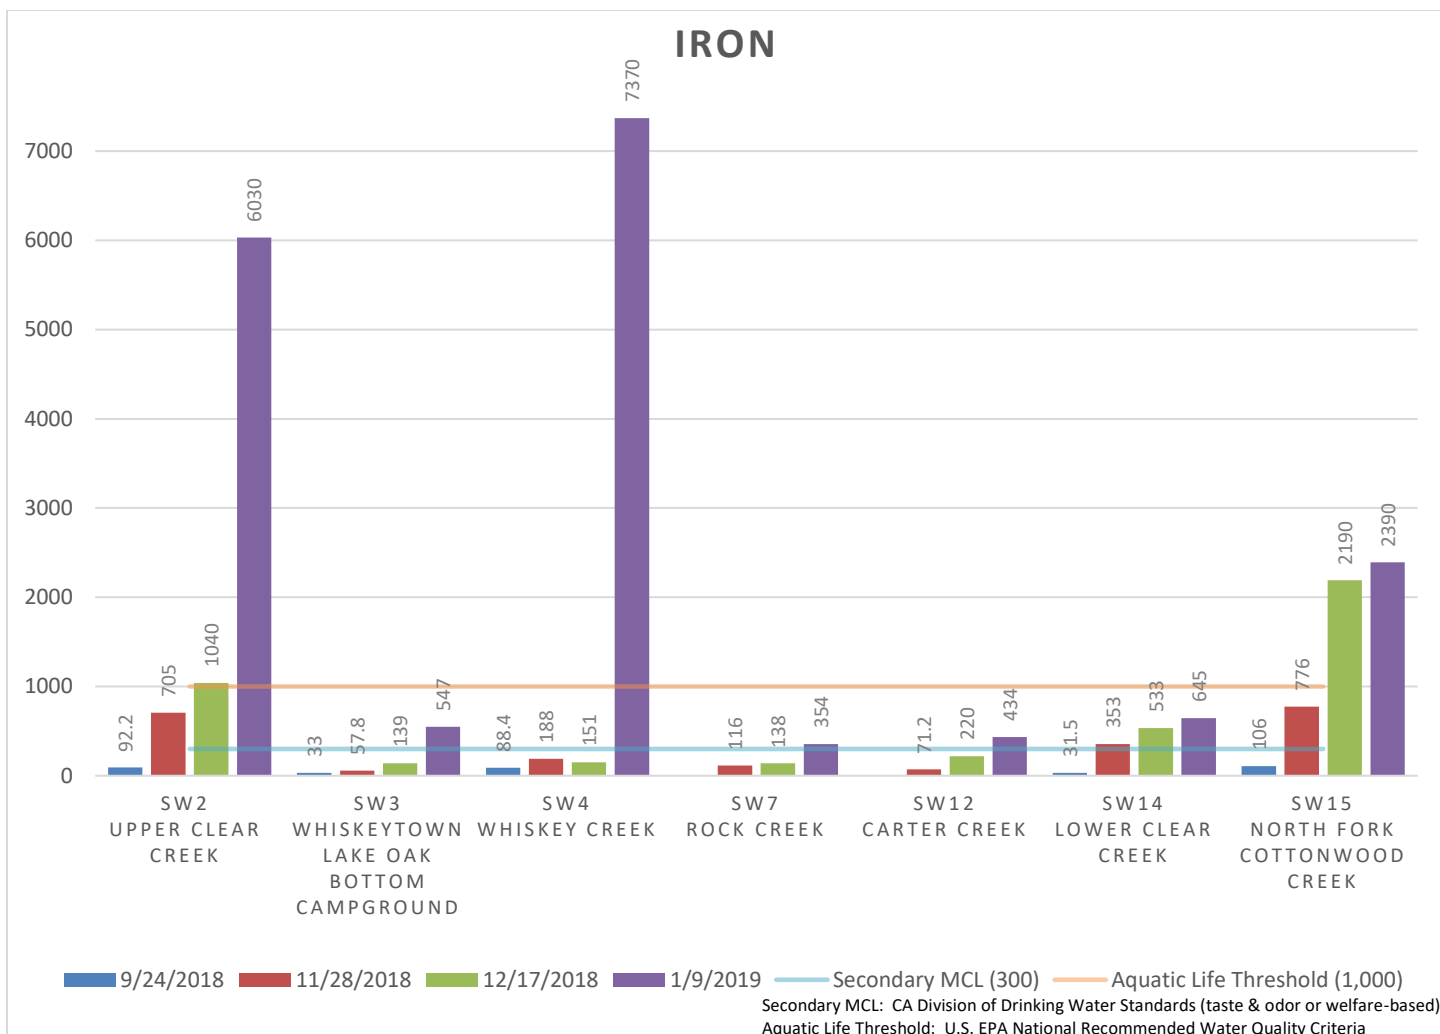
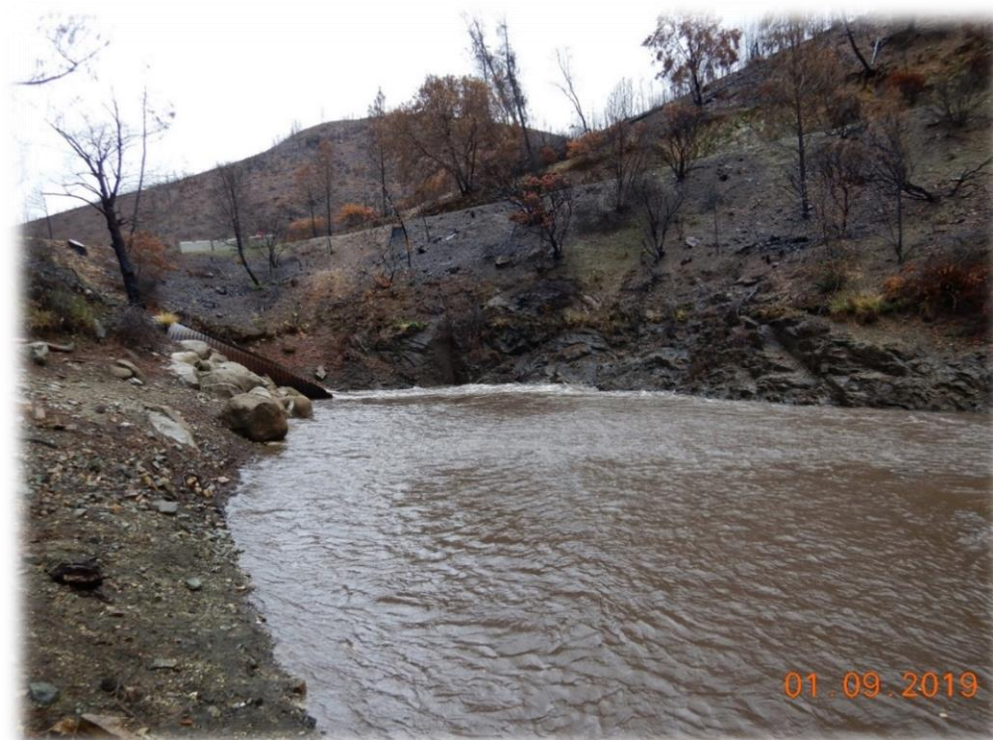
***Elevated turbidity, aluminum, and iron measured at Whiskey Creek
9 January 2019***

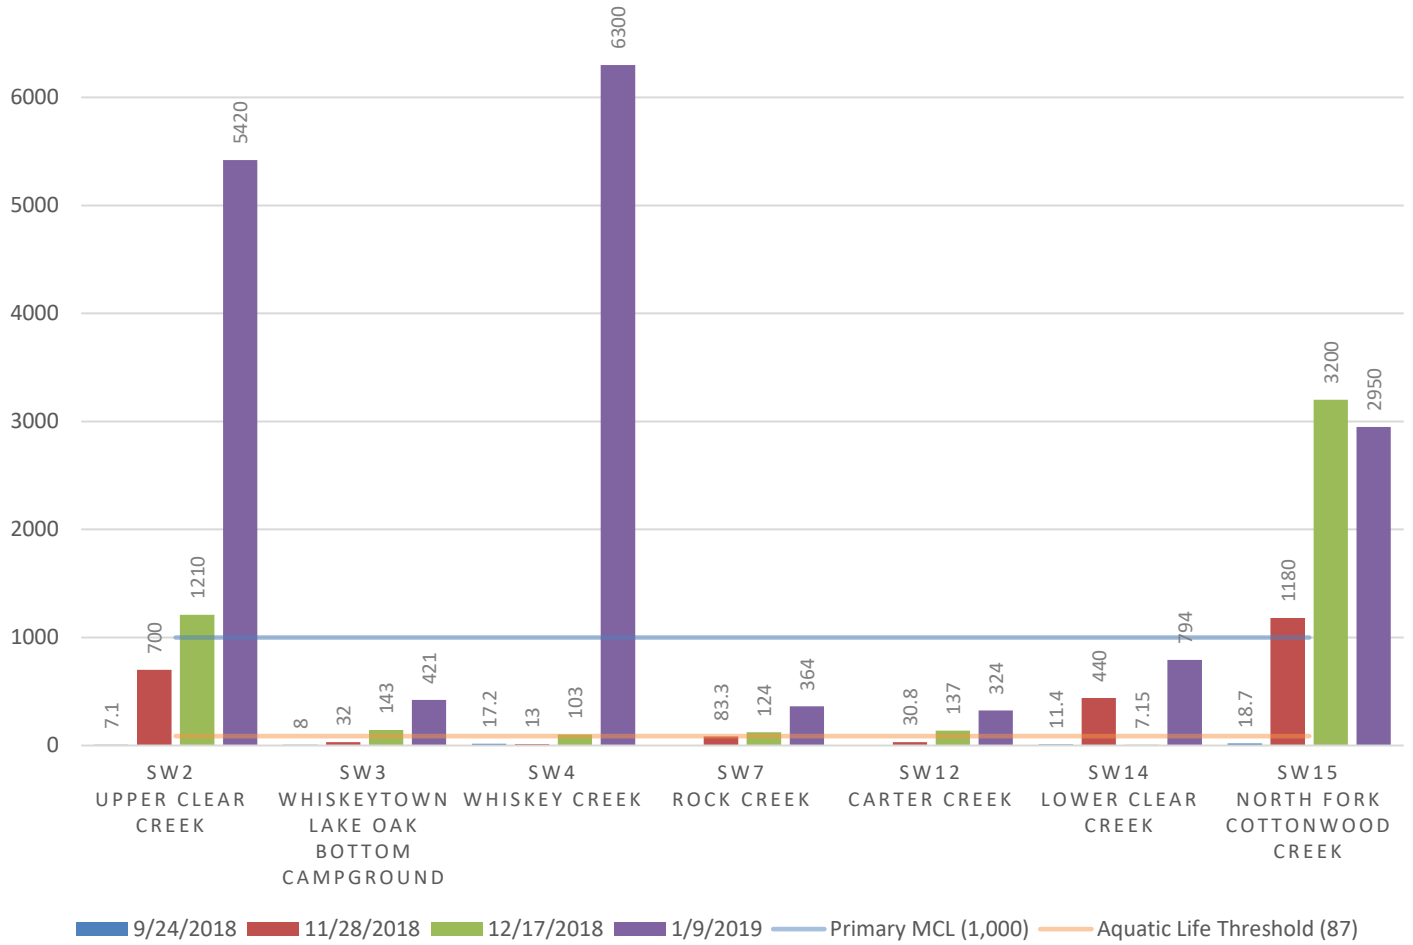
ALUMINUM

Primary MCL: CA Division of Drinking Water Standards (health based + technology & economics)
 Aquatic Life Threshold: U.S. EPA National Recommended Water Quality

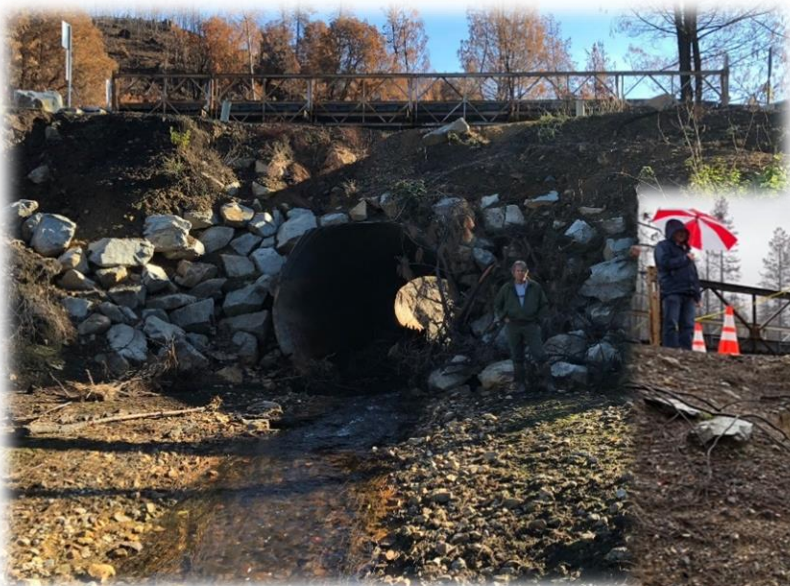
Whiskey Creek Culvert
Fall 2018

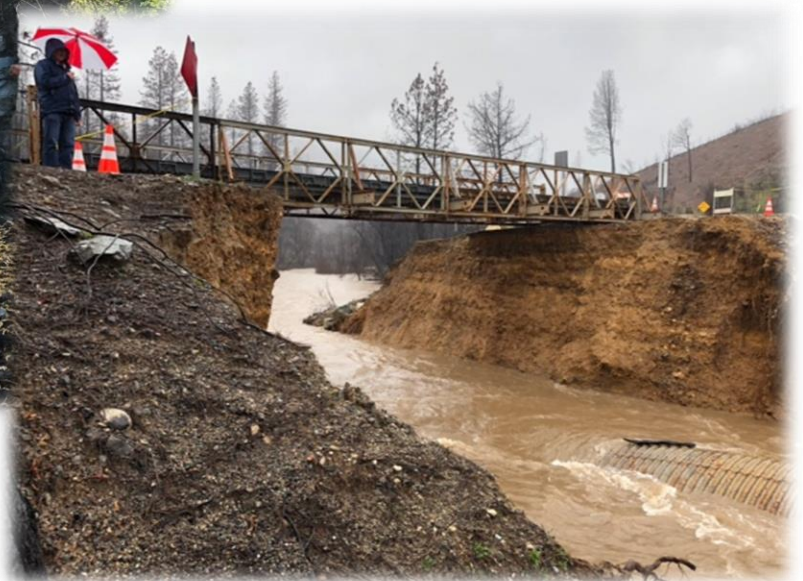
Whiskey Creek Culvert Failure
February 2019

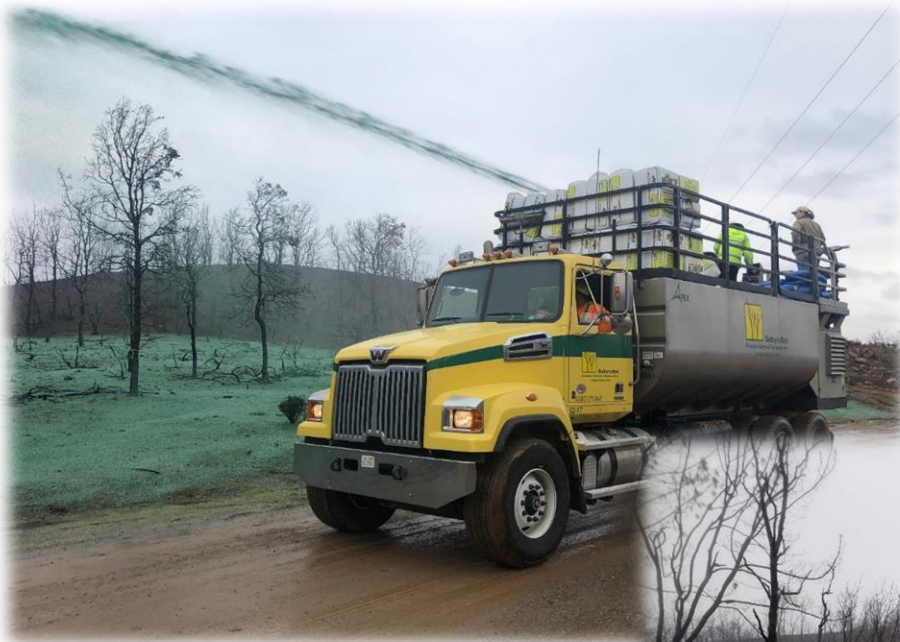
Hydroseed treatment

- Project implementation: Acres of moderate to high severity burn slopes (approximately 20% to 40% slope) near Class I streams = 1,640 acres. Acres under access agreement = 1,350 acres. Erosion control measures include hydroseeding, straw application, culvert improvement, and other measures. Acres treated to date = 626 acres. Culvert improvement designs are complete. Assessment monitoring is underway. Depending on watershed conditions, implementation and assessment activities will continue to 2021.

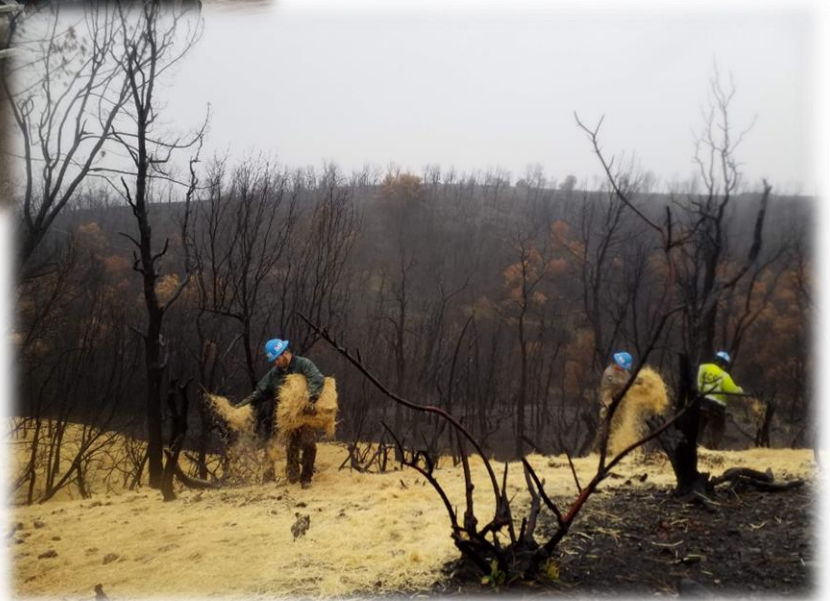
Hand applied straw treatment

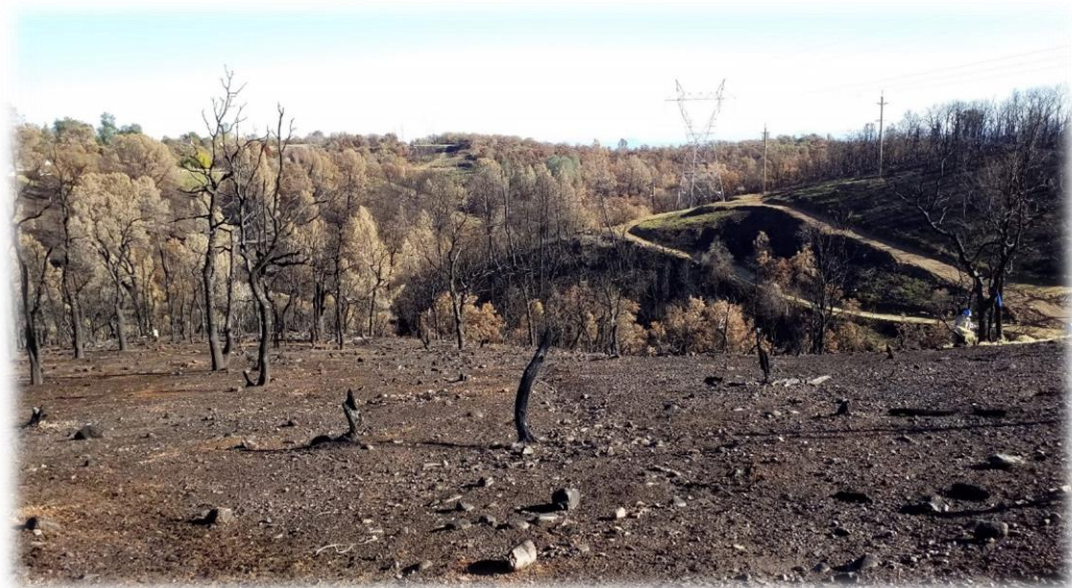
***Before straw treatment Carter Creek
November 2018***

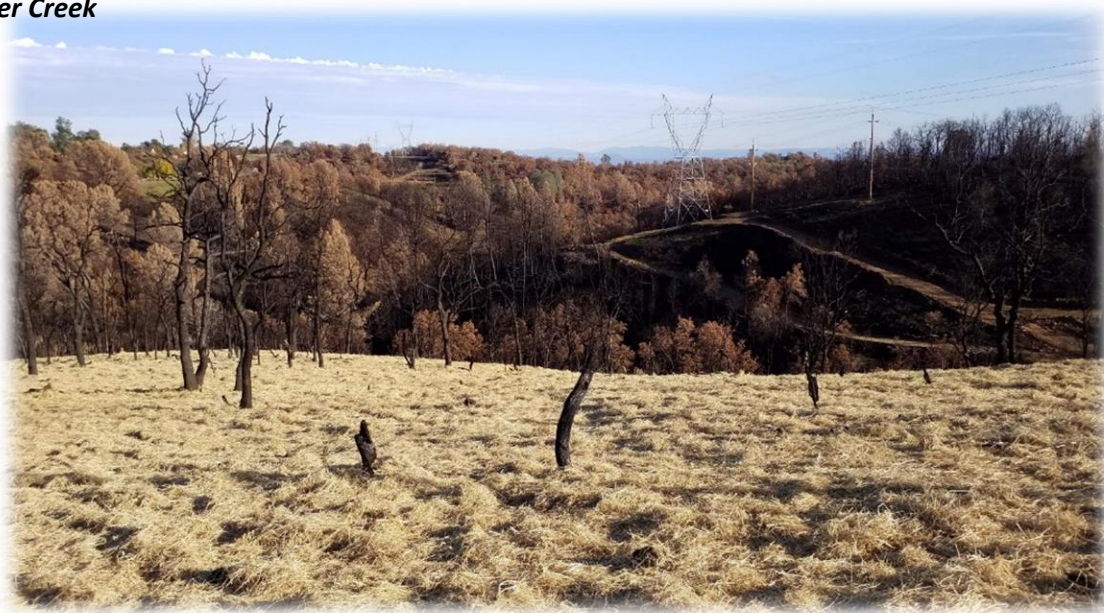
***Hand applied straw and seed treatment Carter Creek
November 2018***

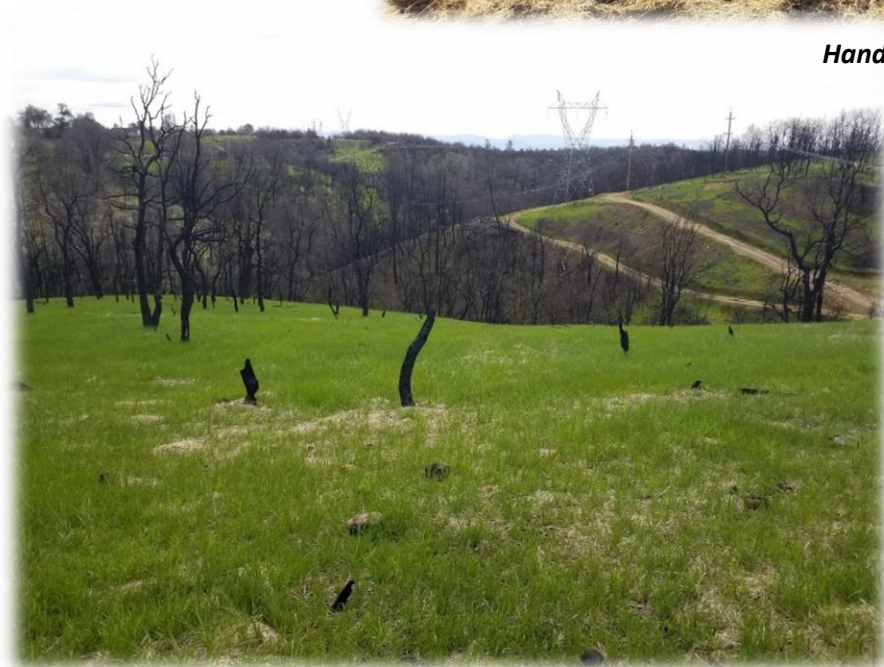
***Hand applied straw and seed treatment Carter Creek
February 2019***

Vegetation growth (soil stabilization) is faster and denser in treated areas than in untreated areas. Hand applied straw generally shows faster plant growth and better erosion protection than hydroseeding. Natural grass growth is better than expected in some low elevation, moderate burn areas. Rainfall totals and intensity are generally higher in the western project area. Sandy soil (decomposed granite) in the western area is more prone to erosion by dispersed overland flow than soils in the eastern area. Limited microplot data show approximately 50% less sediment erosion from overland flow on hydroseed treated slopes, and 75% less for straw treatments during larger storm events. Little rill or gully formation has been observed on treated slopes. This suggests treatments may have also reduced development of concentrated flow pathways that can generate chronic sediment discharge. Initial results suggest reduced erosion and accelerated stabilization in treated areas.

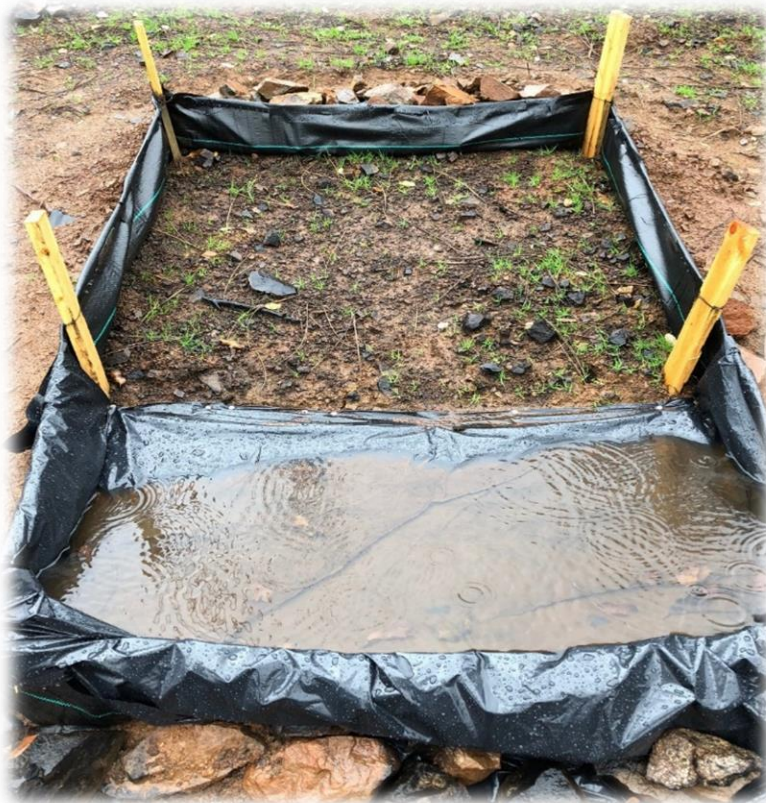
*Microplot with runoff catchment basin
Carter Creek*

- Tracking treated acreage
- Photo monitoring of vegetation and erosion features on treated and untreated sites
- Soil type and slope measurements
- Microplots to assess sediment discharge by overland flow
- Quadrat grid transects to measure vegetation growth and coverage
- Project area rainfall intensity measurements using tipping buckets

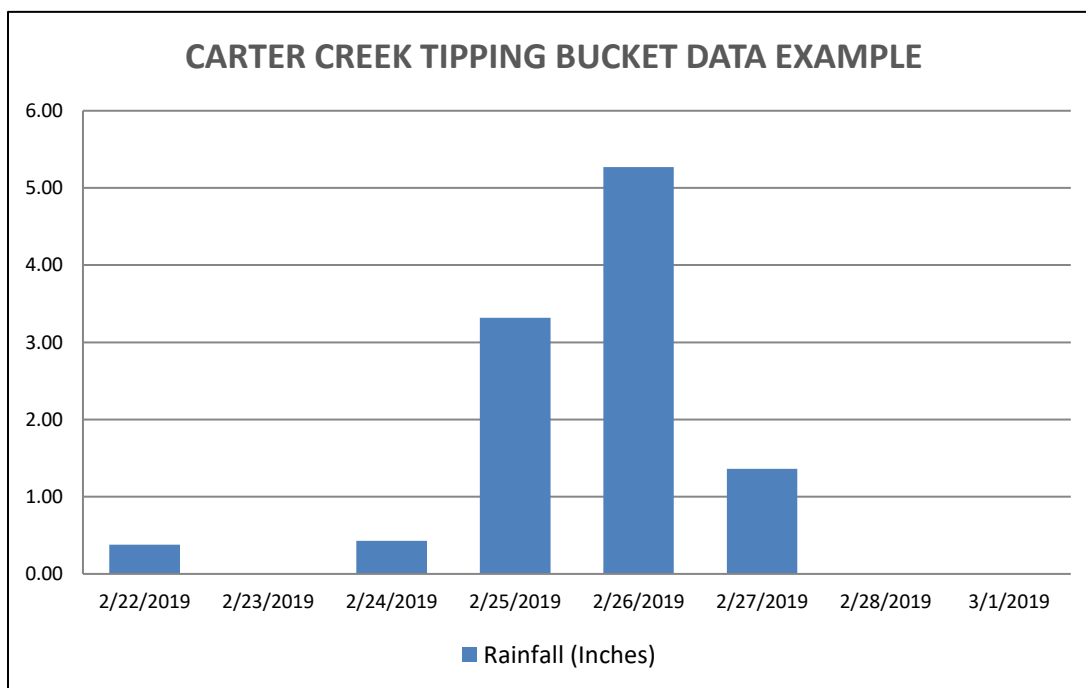
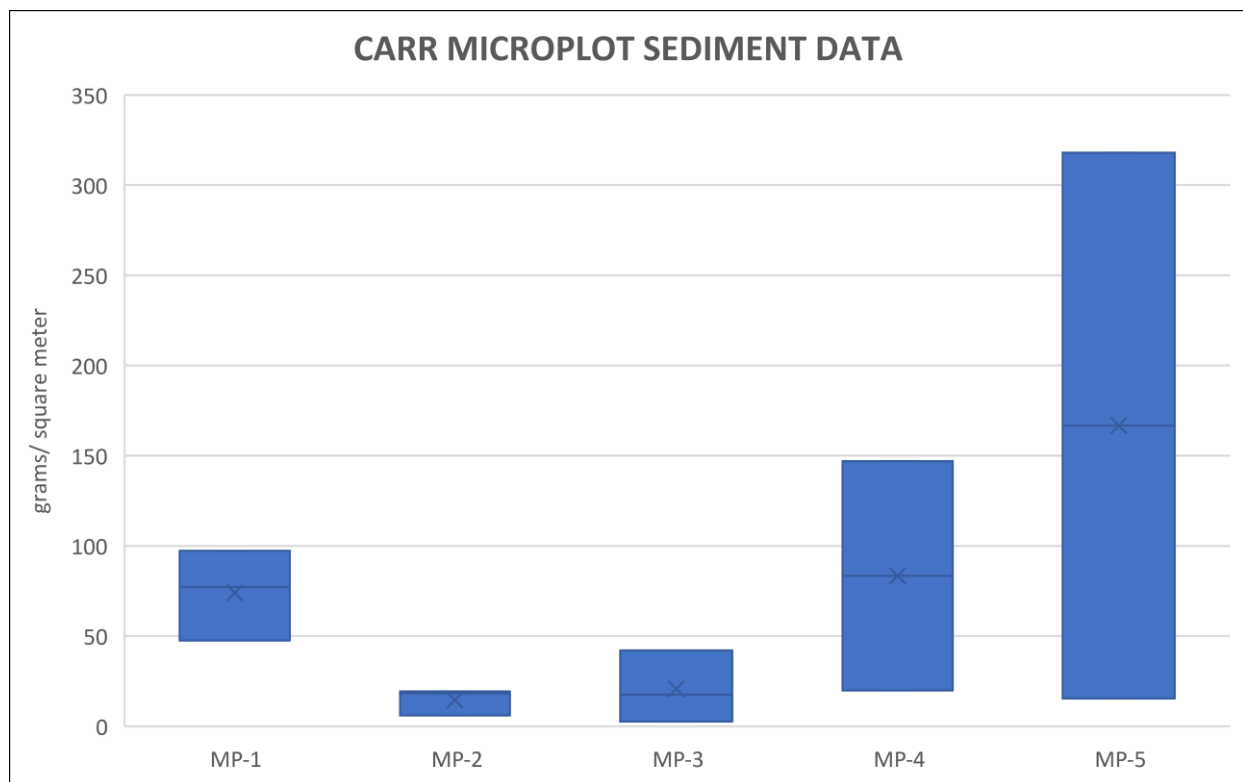
MP-1 – No treatment (bare soil), Carter Cr. (lower watershed)
 MP-2 – Hand straw treatment, Carter Cr.
 MP-3 – Hydroseed treatment, Carter Cr.
 MP-4 – Hydroseed treatment, Whispering Woods (upper watershed)
 MP-5 – No treatment (bare soil), Whispering Woods

Preliminary results based on limited data suggest:
